Evaluating the Implementation of Hazard Analysis Critical Control Point (HACCP) in Small Scale Abattoirs of Tigray Region, Ethiopia

We conducted this assessment at the abattoir of Shire Endaselassie to evaluate the suitability of implementation of hazard analysis critical control point (HACCP) by small-scale abattoirs in the Tigray region of Ethiopia. We used the Shire Endaselassie municipal abattoir as a model because all small-scale abattoirs in the region have similar infrastructural settings, operational procedures, and facilities. The abattoirs are owned by the municipalities of the respective towns. Qualitative data on the abattoir's facilities and its work flow were collected using a survey and experts' observations. Our findings revealed that Shire Endaselassie municipal abattoir lacks basic facilities and equipment that are mandatory for small-scale abattoirs. Moreover, the slaughtering procedure followed in the abattoir was unhygienic and substandard, comparable to backyard slaughtering practices. The abattoir was not equipped with the basic facilities and personnel necessary for implementing HACCP. These findings can be inferred to other small-scale municipal abattoirs

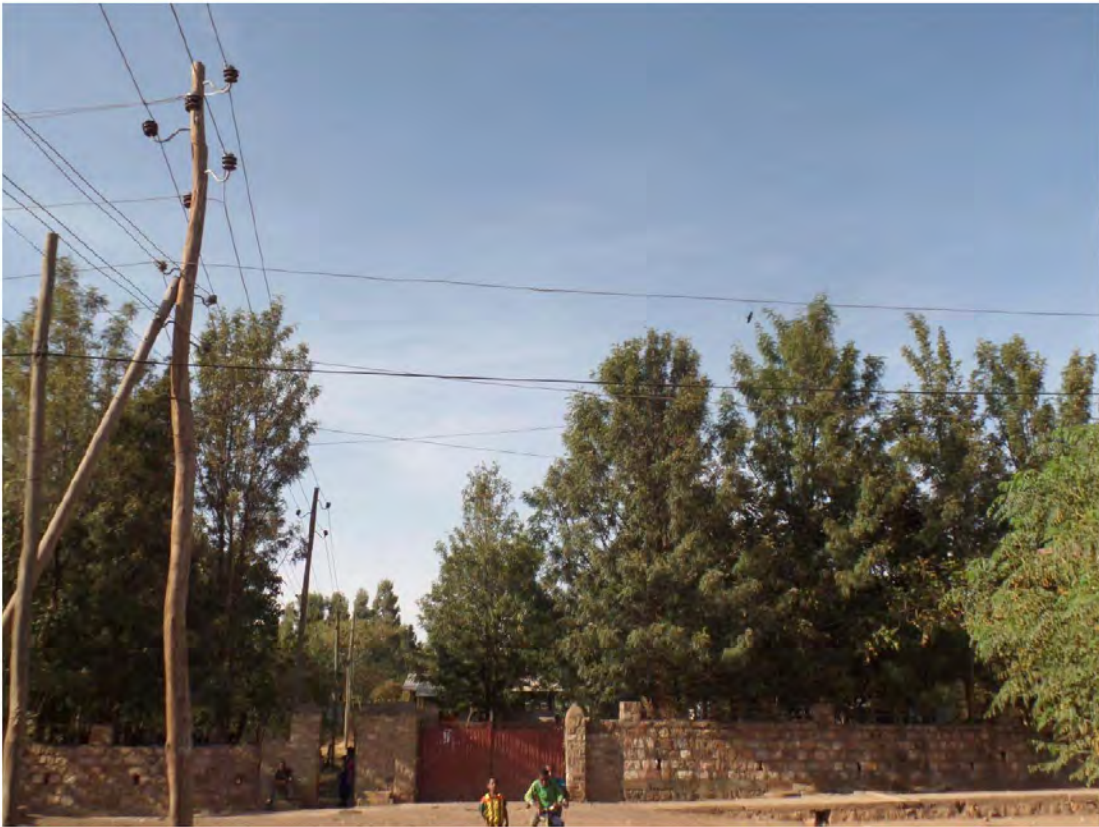
FIGURE 2. External view of abattoir

The slaughterhouse is close to an open market, where live animals (cattle, goats, and sheep) are traded. It is also a site where intensive urban dairy farms and residents are concentrated. Thus, it can be source of diseases to the public and livestock, in contrary to FAO (4) recommendations. With clay as the dominant soil type, the area is characterized by mud or dust during the rainy and dry seasons, respectively. The abattoir compound has also dense vegetation cover (Fig. 2).

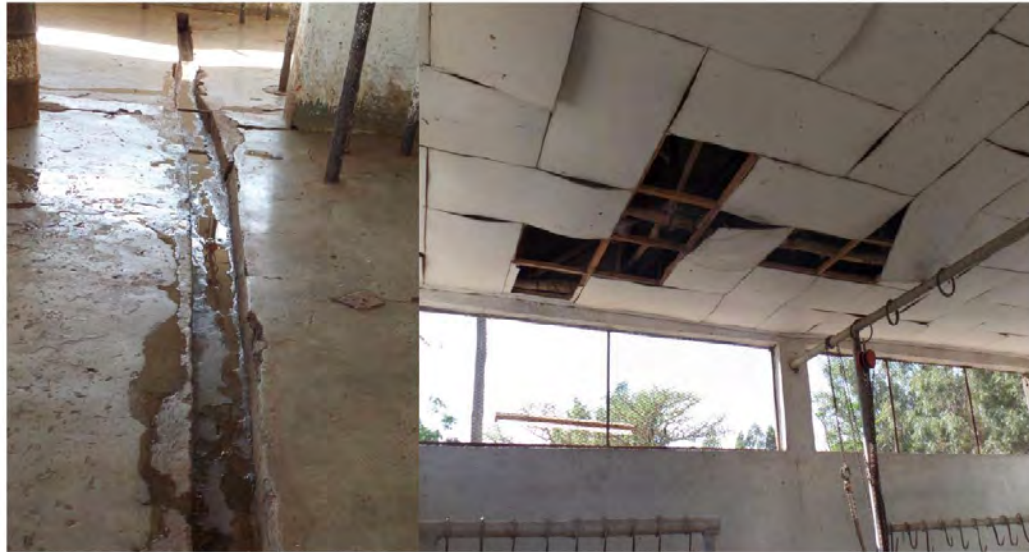
FIGURE 3. Inside view of abattoir (left: floor; right: roof)

The abattoir has one main building and one shed used for lairage. The main building has three compartments; the first two are used for slaughtering cattle, and the third is supposed to be used for slaughtering sheep and goats. The main building has brick walls, a concrete floor, and a corrugated iron sheet roof. The floor has a good slope and drainage system, but it is rough, cracked, and worn. The ditches also were clogged with abattoir waste around the outlets, and the interior of the ceiling was damaged (Fig. 3). Similarly, the walls were not smooth enough to maintain hygienic conditions. These conditions could lead to contamination of processed meats in the abattoir and become source of human infection with various pathogens.

- Municipalities in the region should consider equipping the abattoirs with basic facilities such as chilling equipment, electric power, water, means of transportation, and waste management systems consistent with national and international standards.
- In view of the risk, abattoirs should avoid splitting and washing carcasses on rough and unhygienic floors.
- Because most abattoirs are now located within cities because of urban expansion, they should practice appropriate waste management strategies to ensure public and environmental health.

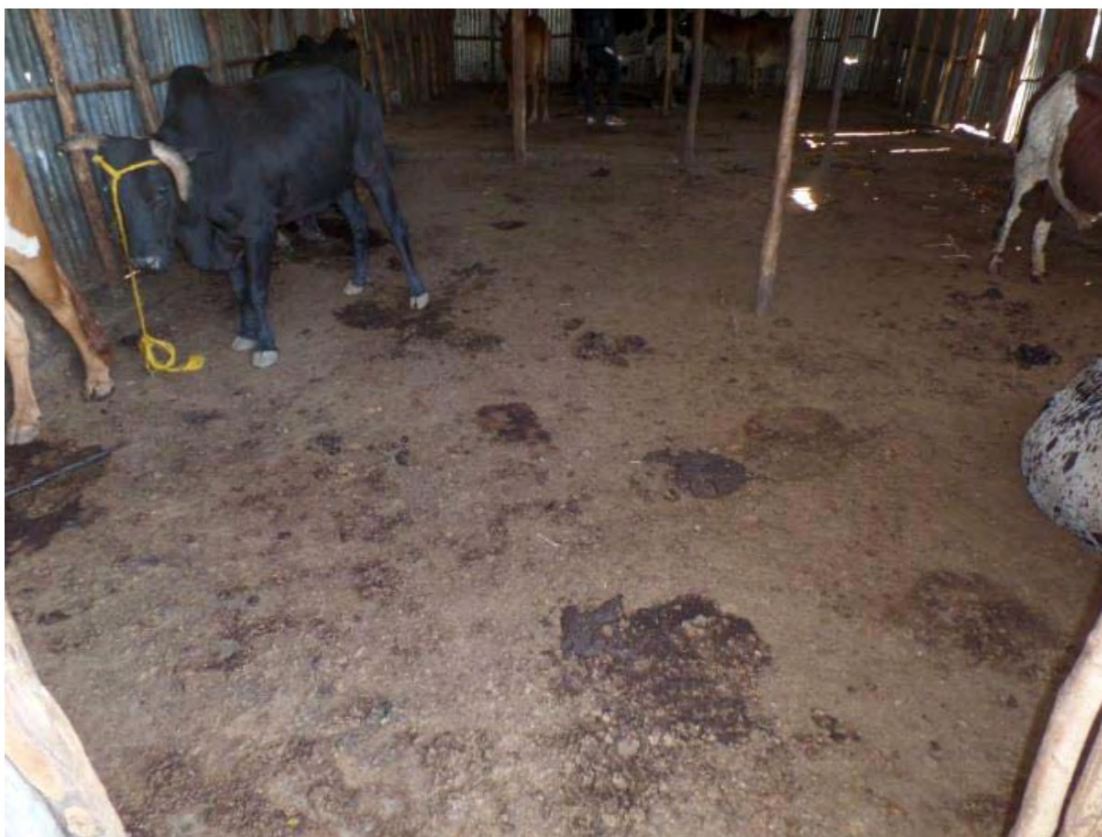
The lairage area is used for holding animals temporarily before they are slaughtered. The walls and roof of the lairage are made of corrugated iron sheets (Fig. 4). The abattoir lacks showers as well as changing rooms. These findings were not consistent with the recommendations of FAO (4). We also noticed that the abattoir employees working without protective clothing. A similar finding was reported in a study conducted in Mekelle, where significant numbers of workers were not wearing protective clothing during slaughtering operations (15). Since meat handlers can be sources of microbial-contamination, measures to reduce or eliminate such contamination should be considered (16).

FIGURE 4. Live animals holding shed (lairage)

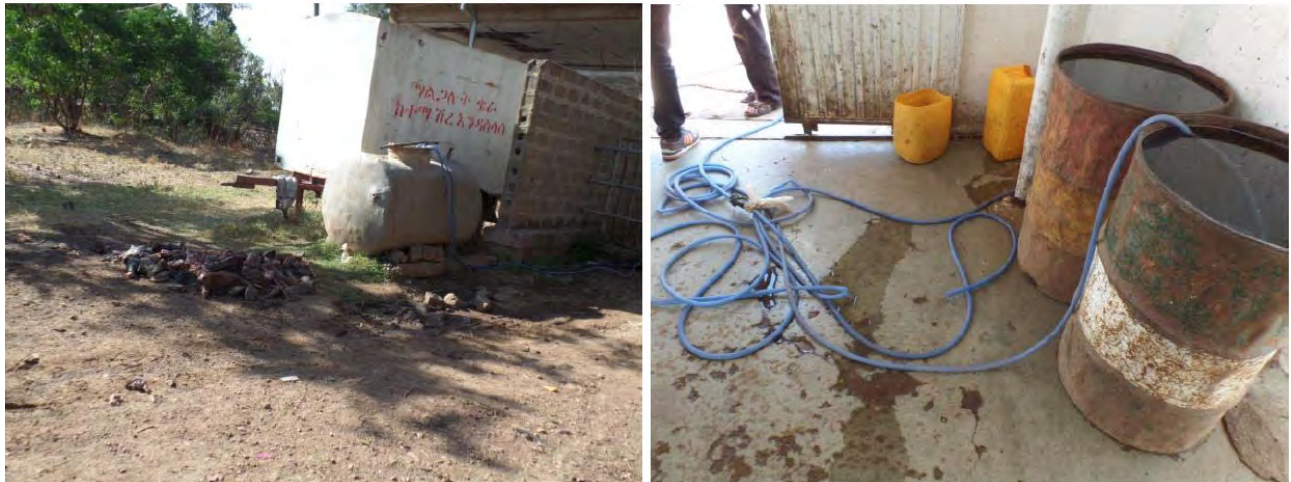
The supply of clean water with adequate pressure is essential for any abattoir to have hygienic and safe slaughtering operations. However, Shire Endasselassie municipal abattoir has no adequate supply of water to maintain the required standards of hygiene. Although there was a waterline connected to the municipal's water supply system, there was a critical shortage of water in the abattoir. Pressurized water is important for washing visceral organs and carcasses soiled with gastrointestinal contents, as well as for cleaning the floor and walls of the slaughterhouse (4). We observed that the abattoir is obliged to buy water from unknown and uncertified sources such as private wells of unknown quality (Fig 5). The cost of water is also high, causing unnecessary costs to the abattoir and perhaps compromising the hygienic slaughtering operations in the abattoir.

FIGURE 5. Water supply (left: water tank; right: barrels)

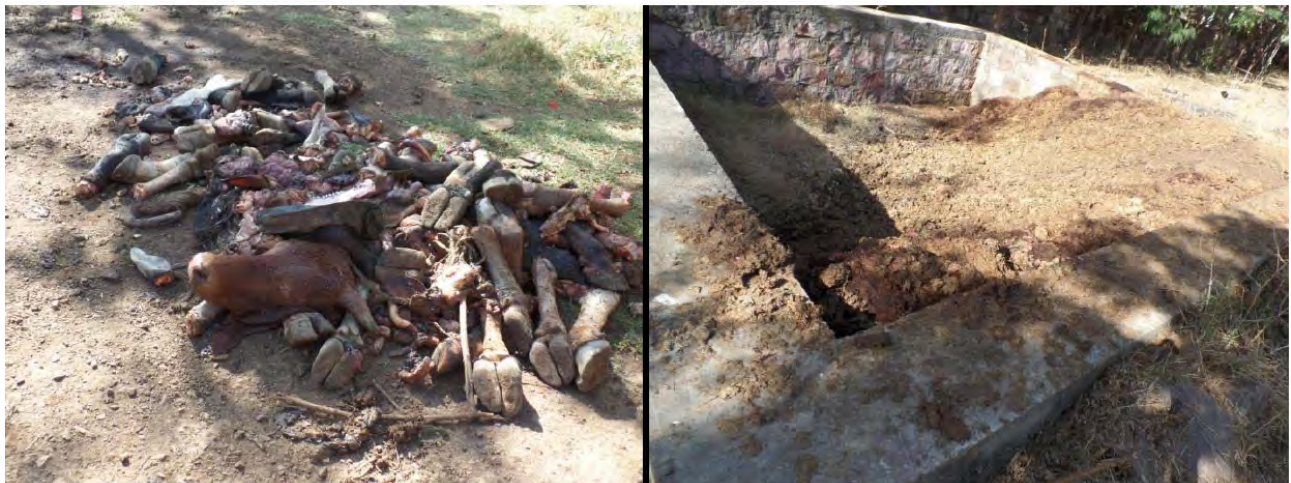
FIGURE 6. Wastes accumulated within the abattoir (left: trimmings; right: rumen contents)

Proper waste management in an abattoir is a critical factor for ensuring both public health and environmental safety. However, liquid and solid waste management practices have not yet been established at Shire Endasselasie abattoir. We observed a great deal of solid waste that had been accumulated in a small pit. Bones and liquid wastes were disposed together within the compound, close to the main slaughtering unit. This waste could become source of environmental pollution and carcass contamination. Moreover, several trimmings were observed to be inappropriately disposed of in the abattoir compound

(Fig. 6). These trimmings attract pets, since the abattoir has no pet-proof fence, and access of pets to waste has the potential to perpetuate the life cycle of various parasites and pathogens. Since slaughterhouse waste is a potential reservoir for several human pathogens, an effective and safe method of waste disposal is essential to reduce the risk of human diseases, that can originate from slaughterhouses (9). The abattoir also lacks an incinerator for burning trimmings and rejected carcasses.
